# California Regional Water Quality Control Board Central Valley Region

**NOTICE OF VIOLATION, CONSTRUCTION STORM WATER GENERAL PERMIT NO. CAS000002, DEL RAPINI CONSTRUCTION INC., WID NO. 5S03C337319, AMADOR COUNTY**

# Storm Water Construction General Permit Inspection Report

Pine Grove Bluffs

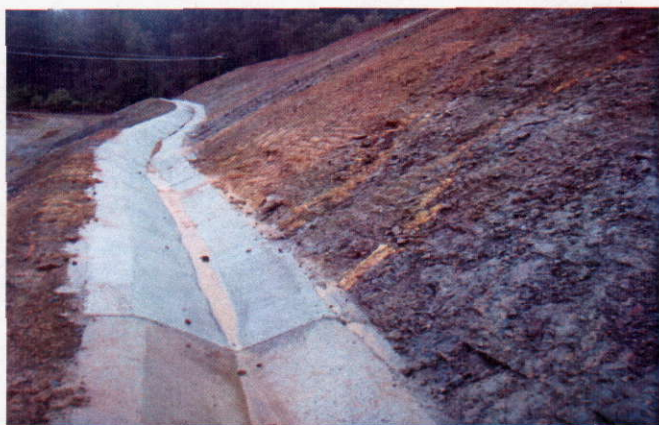
**Figure 1:** One of the many areas where soil is slumping on the steep slopes on the northern side of the project

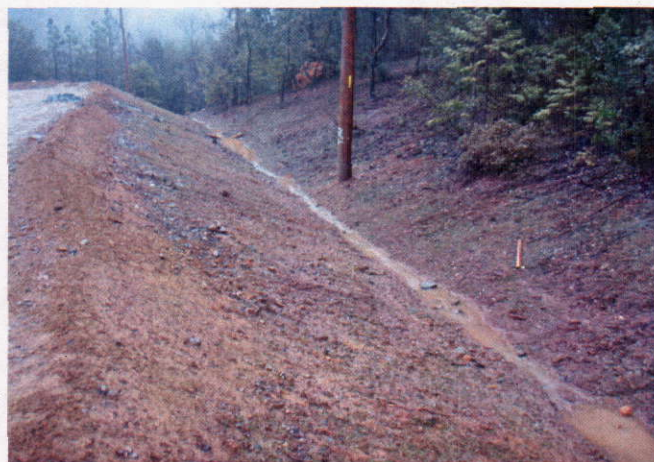
**Figure 4:** Lack of an effective combination of erosion and sediment control BMPs

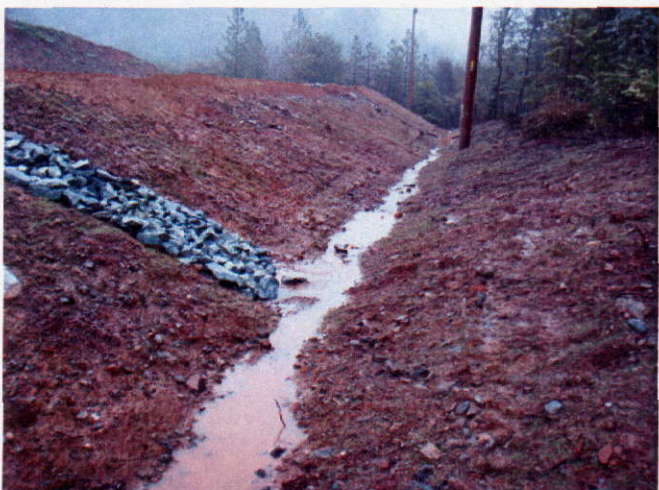
**Figure 5:** Lack of effective BMPs on the slopes and lack of BMPs in a defined drainage channel

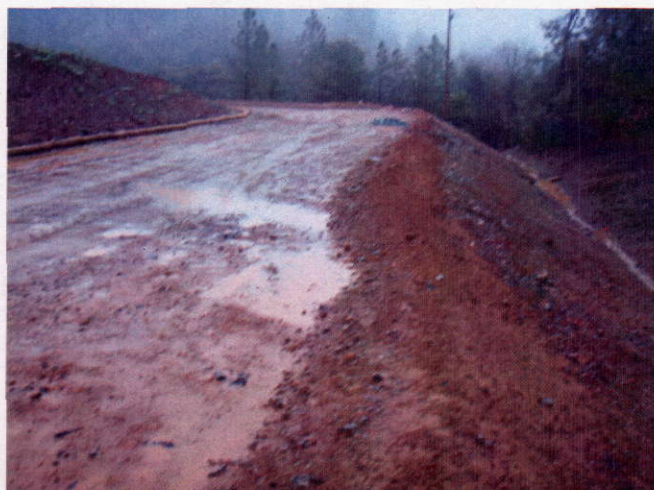
**Figure 6:** Lack of an effective combination of erosion and sediment control BMPs

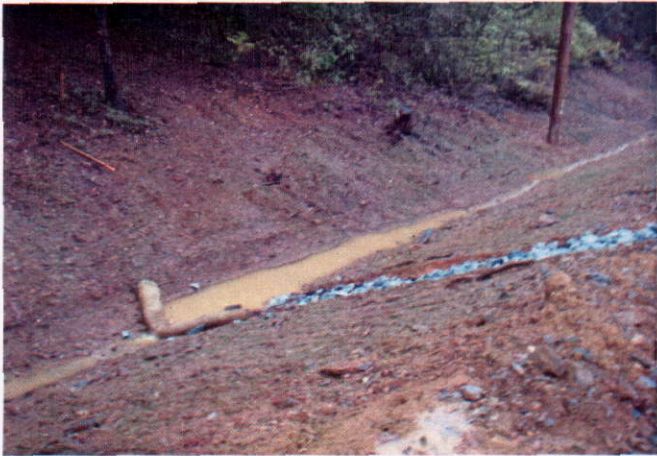
**Figure 7:** Lack of an effective combination of erosion and sediment control BMPs

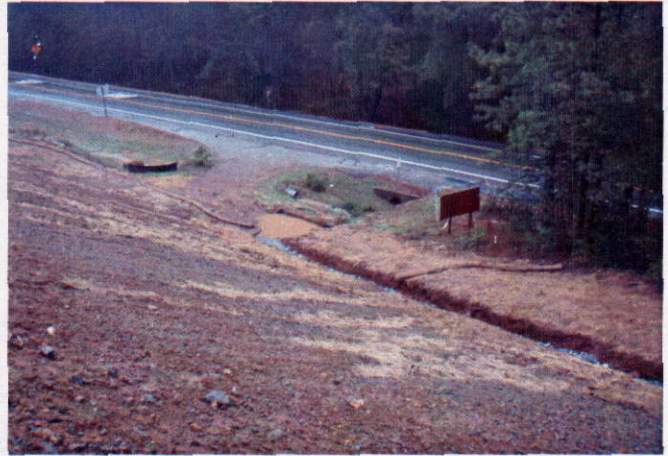
The discharge of sediment-laden water from your site is a violation of Discharge Prohibition A.3 of the General Permit, which states, *"Storm water discharges shall not cause or threaten to cause pollution, contamination, or nuisance."* Sediment-laden storm water from your construction site threatened to cause a condition of pollution and/or nuisance in Jackson Creek, therefore, is a violation of Prohibition A. 3. (See photographs 8, 15, 23-25).

**Figure 8:** Partially protected slope Note: the turbid discharge leaving the site which flows directly under the roadway and into the creek

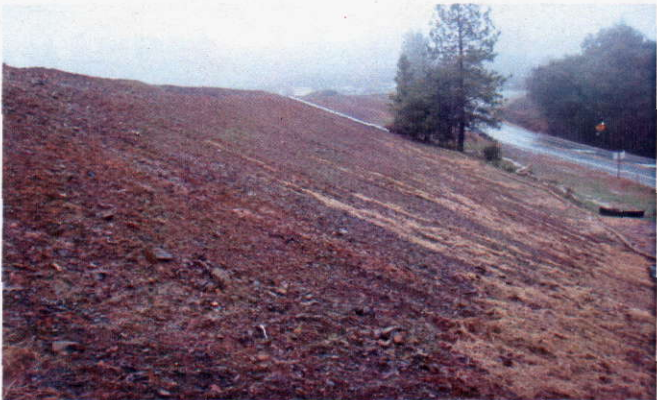
**Figure 9:** Poorly protected slopes

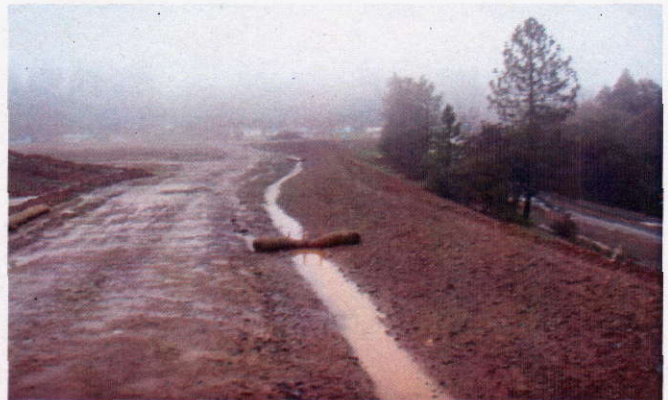
**Figure 10:** Lack of an effective combination of erosion and sediment control BMPs on a portion of the project

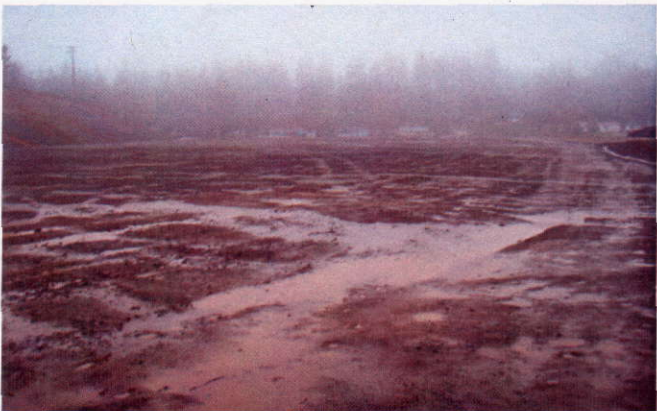
**Figure 11:** Lack of an effective combination of erosion and sediment control BMPs on another portion of the project

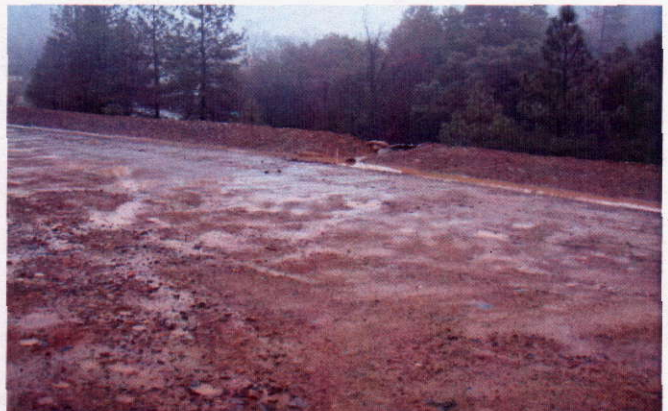
**Figure 12:** Lack of an effective combination of erosion and sediment control BMPs on still another portion of the project

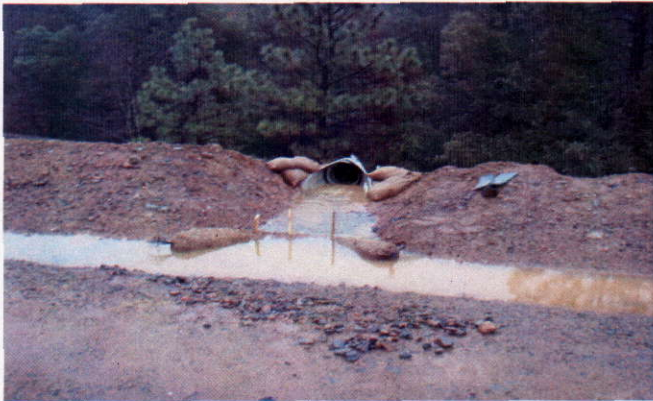
**Figure 13:** Inadequate BMPs at a location where storm water flows from the site into a down drain which directly flows under the roadway and into the creek

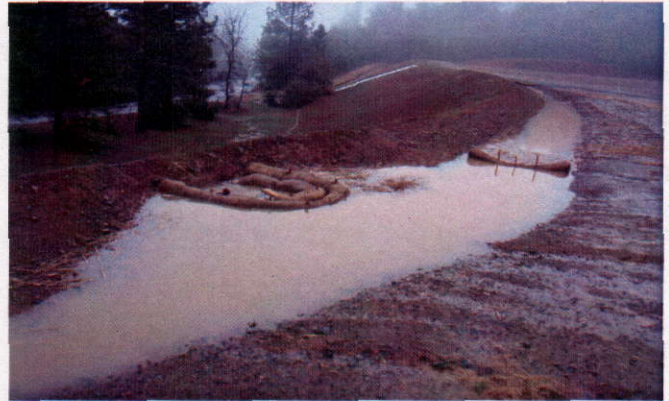
**Figure 14:** Inadequate BMPs at another one of the discharge areas

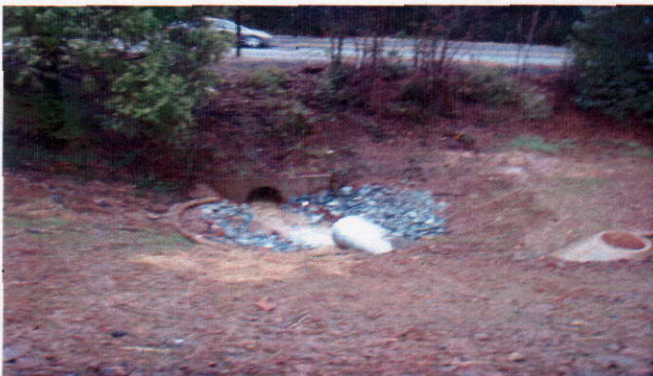
**Figure 15:** Storm water discharge from the site entering the culvert which flows under the highway and directly into the creek

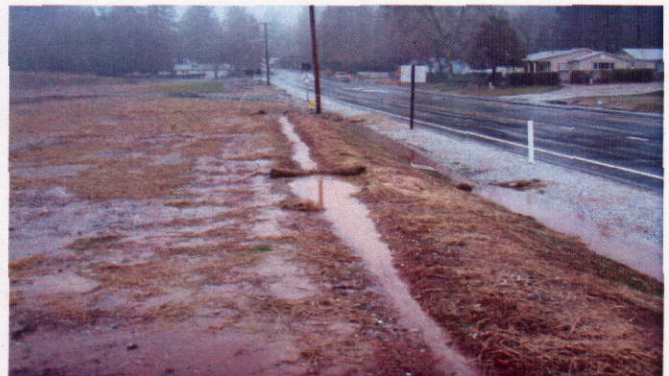
**Figure 16:** Storm water flowing on the site along Ridge Road

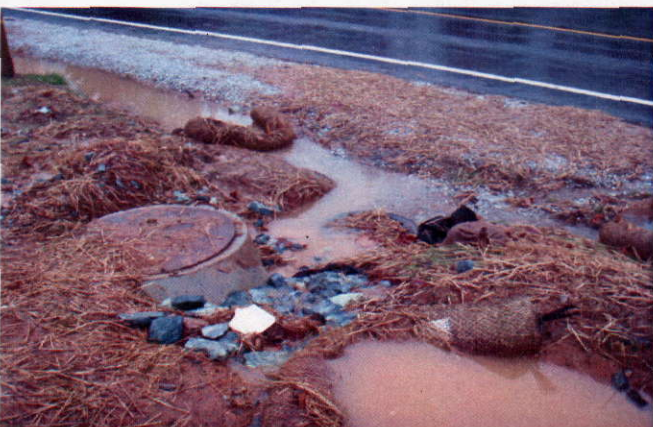
**Figure 17:** Poorly protected drain inlet along Ridge Road

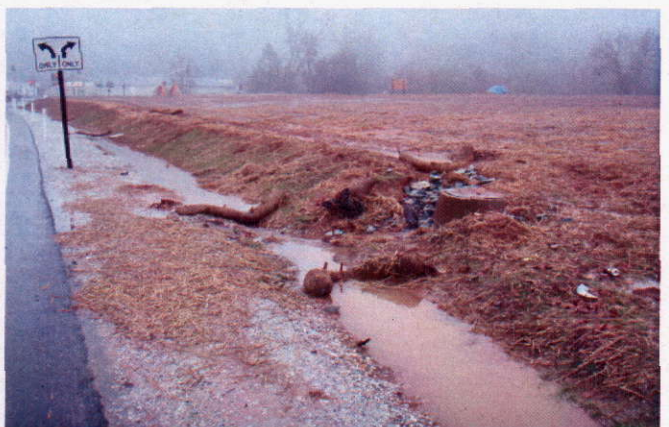
**Figure 18:** Another view of the poorly protected drain inlet

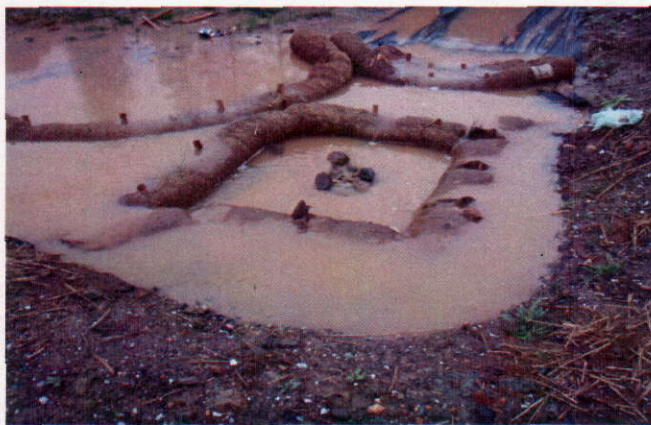
**Figure 20:** Ponded storm water around another drain inlet

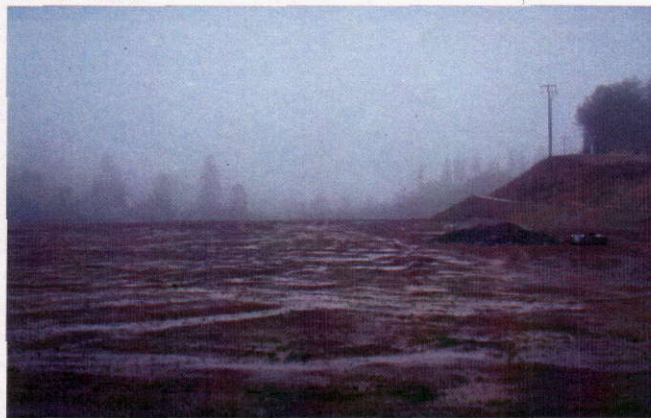
**Figure 22:** Lack of an effective combination of erosion and sediment control BMPs on another portion of the project

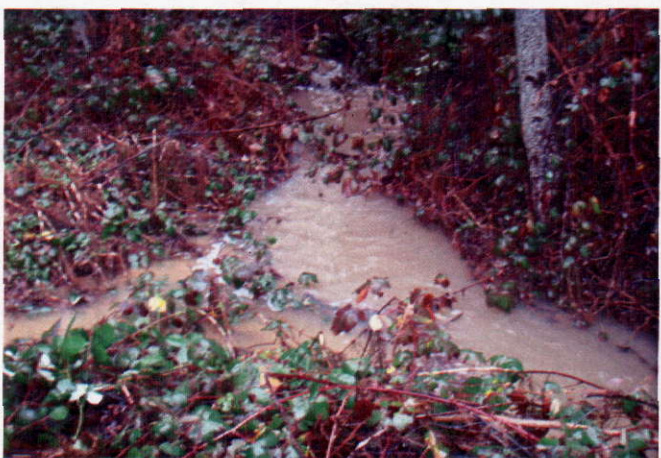
**Figure 23:** Storm water from the site mixing in the creek at one of the discharge locations Note: the storm water from the site is on the left hand side of the photograph

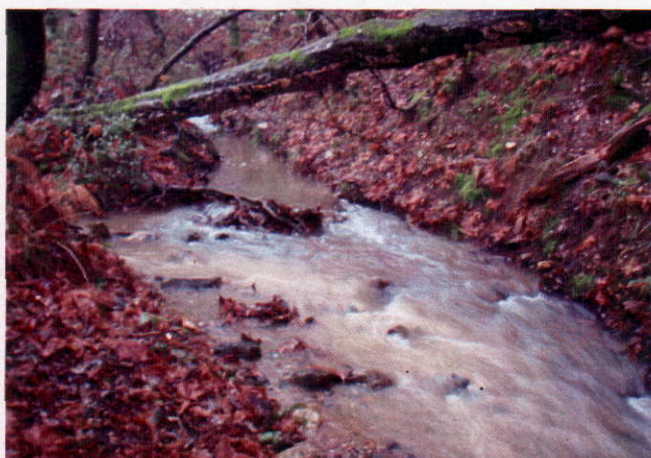
**Figure 24:** Storm water from the site mixing in the creek at another discharge location Note: the storm water from the site is on the left hand side of the photograph
